PSD Export error list 15.02.2021 14:42:56

Errors: 133

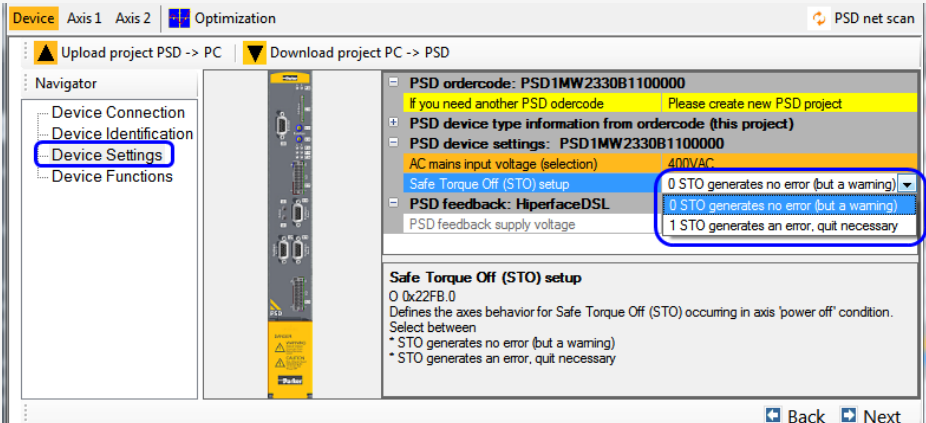
Error:	Safe Torque Off (STO) was triggered in power off ¹⁾ state (-> warning).
Cause of Error:	Standard drive: STO inputs are active (A and/or B are low (0V)), drive reaction is delayed 100ms ²⁾ FSoE drive: Safety option board (SoB) commanded STO
Measure:	<p>To remove the Event: Close the safety circuit, the drive (if no other error is present) will automatically leave the STO state.</p> <p>If the STO event is not desired:</p> <ul style="list-style-type: none">• Check 24V on STO inputs. <p>If the safety option board (SoB) is used/desired:</p> <ul style="list-style-type: none">• Is it mounted (correctly) and correctly configured?• Is there any error message given by the SoB? <p><u>Notes:</u></p> <ul style="list-style-type: none">➤ The drive STO inputs can be monitored on Axis level via object 0x60FD 'DigitalInputs' and 0x31C1.02 'STOx'. On device level object 0x2070 'DigitalDrive_IO_States' could be monitored. The SoB status can be monitored on object 0x2511.0x18 (all axis) or 0x2511.0x15...0x17 (axis1...3). The STO event after about 100ms ²⁾ is also visible in fieldbus profile status word (ZSW1) 0x6041 bit 15 (for both DS402 and PROFIdrive).➤ PSD1MW3: Axis 3 is linked to Axis 2 STO input signals.➤ This warning is only reported if in the device settings of the configuration 'STO setup' is set to option '0 STO generates no error (but a warning)'

<p>This STO reaction type can also be defined on object level via 0x22FB.0 'STO_Setup'.</p> <p>For value '1 STO generates error, quit necessary' instead of this warning the error 0x5492 'STO activated in power off state (error)' is generated.</p>

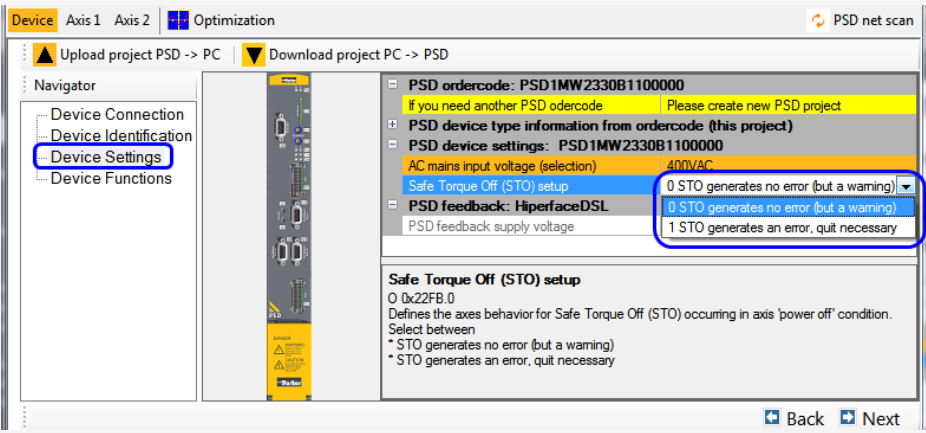
Error:	Safe Torque Off (STO) was triggered in power off ¹⁾ state (-> error).
Cause of Error:	<p>Standard drive: STO inputs are active (A and/or B are low (0V)), drive reaction is delayed 100ms²⁾</p> <p>FSoE drive: Safety option board (SoB) commanded STO</p>
Measure:	<p>To remove the Event: Close the safety circuit and acknowledge the drive error.</p> <p>If the STO event is not desired:</p> <ul style="list-style-type: none"> • Check 24V on STO inputs. <p>If the safety option board (SoB) is used/desired:</p> <ul style="list-style-type: none"> • Is it mounted (correctly) and correctly configured? • Is there any error message given by the SoB? <p><u>Notes:</u></p> <ul style="list-style-type: none"> ➤ The drive STO inputs can be monitored on Axis level via object 0x60FD 'DigitalInputs' and 0x31C1.02 'STOX'. On device level object 0x2070 'DigitalDrive_IO_States' could be monitored. The SoB status can be monitored on object 0x2511.0x18 (all axis) or 0x2511.0x15...0x17 (axis1...3). The STO event after about 100ms ²⁾ is also visible in fieldbus profile status word (ZSW1) 0x6041 bit 15 (for both DS402 and PROFIdrive). ➤ PSD1MW3: Axis 3 is linked to Axis 2 STO input signals. ➤ This error is only reported if in the device settings of the configuration 'STO setup' is set to option '1 STO generates error, quit necessary'

<p>This STO reaction type can also be defined on object level via 0x22FB.0 'STO_Setup'.</p> <p>For value '0 STO generates no error (but a warning)' instead of this error the warning 0x5491 'STO activated in power off state (warning)' is generated.</p>
